Home Inspection Report

Port Charlotte, FL 33954

Wednesday April 17, 2019

041719-1

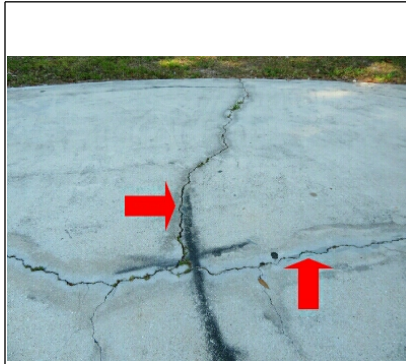
Typical driveway settling / expansion cracks

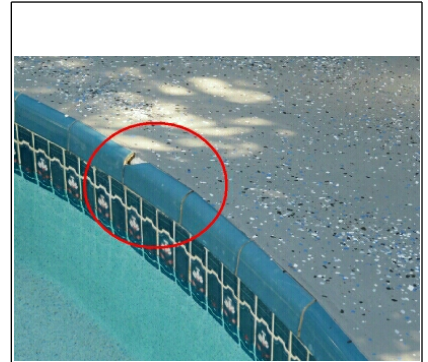
Pool coping tiles are damaged / chipped, recommend replacement to prevent getting cut

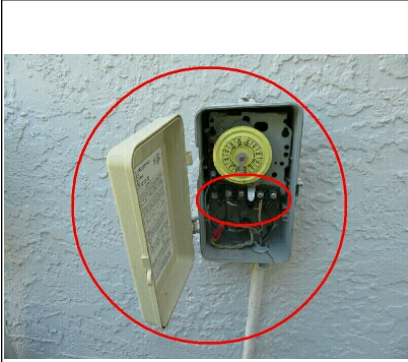
Pool control time clock panel box is damaged, recommend replacement. Also protection safety cover is missing over electrical wire connections

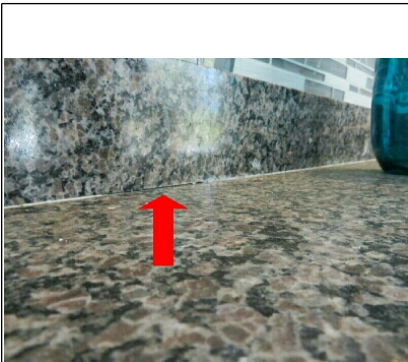
Recommend adding sealant between countertop and backsplash connection to prevent future water entry

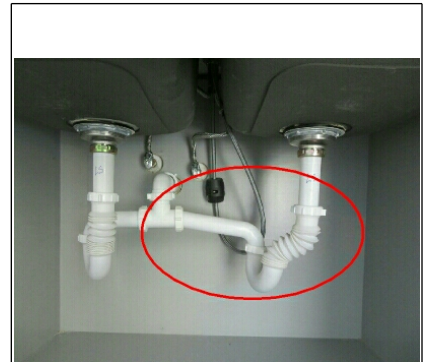
Sink plumbing connections are improperly pitched, recommend repair / realignment /adjustment of the drain piping to ensure proper drainage.

Sink plumbing connections, recommend repair / realignment /adjustment of the drain piping to ensure proper drainage

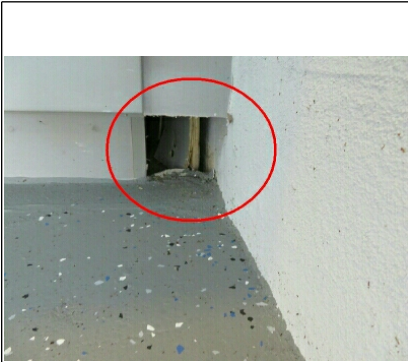
Damaged / missing cabinet toe kick

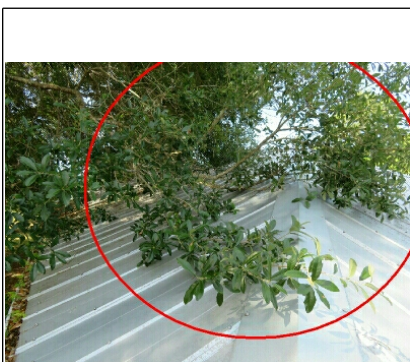
Recommend cutting trees hanging into roof

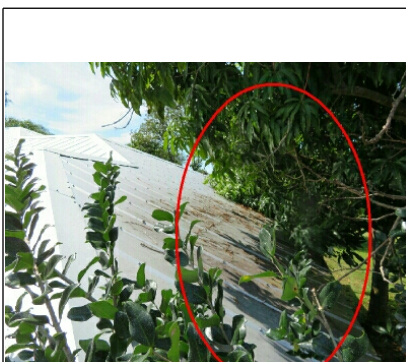
Recommend cutting trees hanging into roof

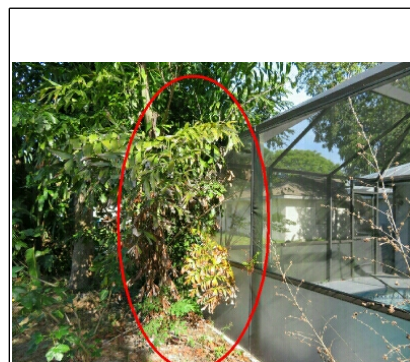
Recommend cutting trees hanging into pool cage

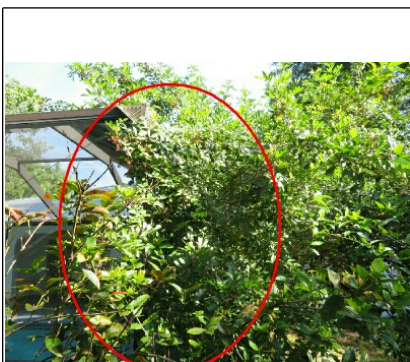
Recommend cutting trees hanging into pool cage

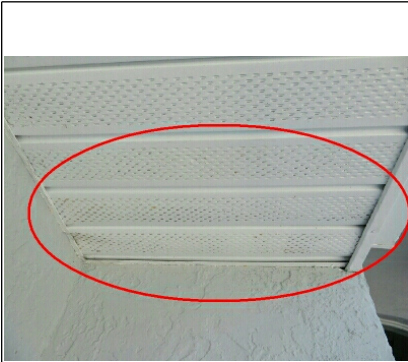
Note: The soffit section appear to have been recently painted, in the area where garage ceiling was stained the soffit material has signs of water damage and rust, which would indicate that the roof perhaps is still leaking . However there was No elevated moisture reading detected when tested at time of inspection. Recommend further investigation by licensed roof contractor.

Soffit section showing visible signs of active roof leaking

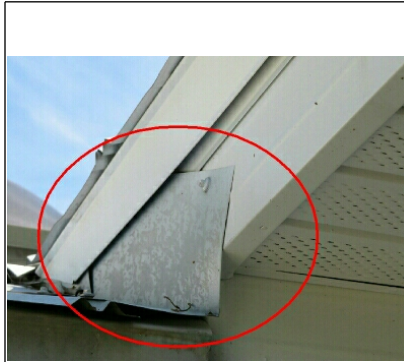
Improper flashing installation Southwest corner

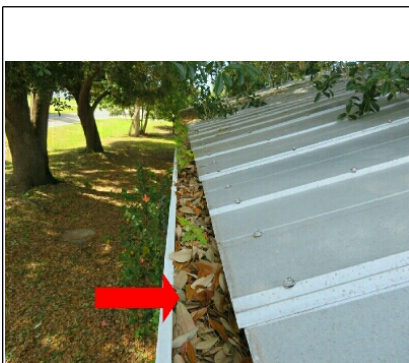
Inside of gutters are full of debris
 recommend cleaning to prevent
 future development

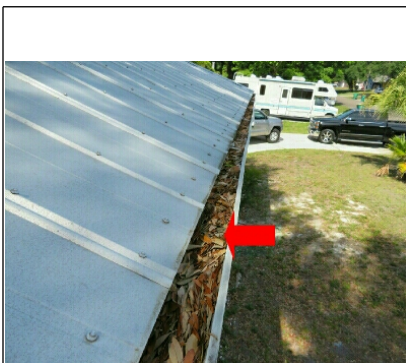
Inside of gutters are full of debris
 recommend cleaning to prevent
 future development

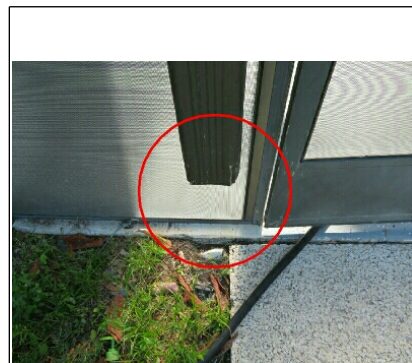
Recommend adding downspout
 extensions to discharge water
 away from house

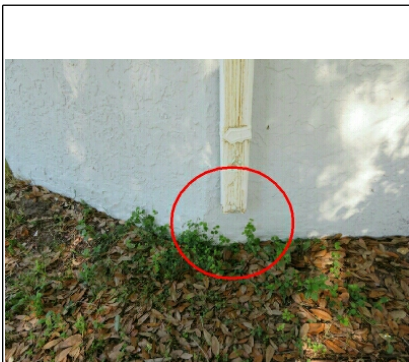
Recommend adding downspout
 extensions to discharge water
 away from house

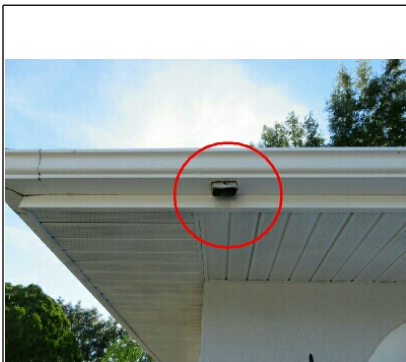
Missing downspout (North corner
 at overhead garage door)

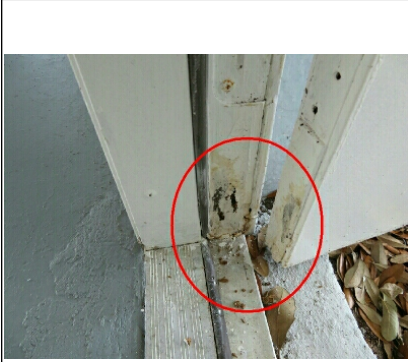
Comments: Garage entry door framework / trim showing signs of deterioration

Garage entry door framework / trim showing signs of deterioration

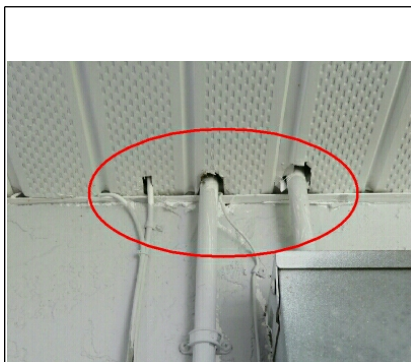
Recommend adding sealant around piping to prevent future pest entry

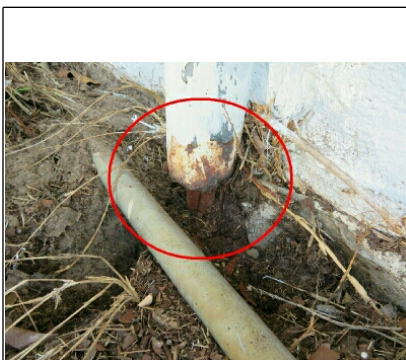
Comments Conduit for underground service rusted-through at grade. Recommend licensed electrician repair as needed.
Grounding Rod clamp connection is deteriorated, the clamp/wire are not properly attached to grounding rod. Recommend repair by licensed electrical contractor.
No GFCI outlet protection present on exterior outlets, recommend installing GFCI outlets.

Electrical service conduit pipe has rusted and feeder wires are exposed, recommend repair / replacement as needed

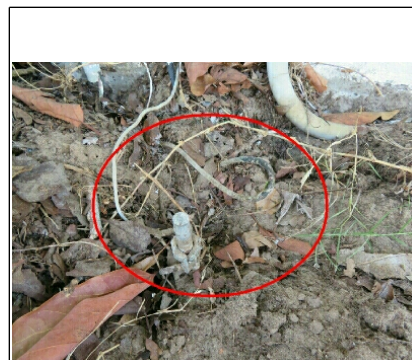
Electrical service grounding clamp / wire are not properly attached to grounding rod

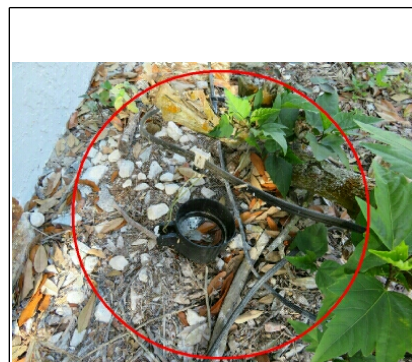
Planter bed lighting is damaged, an wiring is exposed

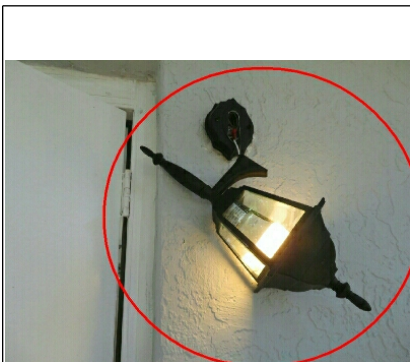
Light fixture right side of garage door, got damaged when door was opened.

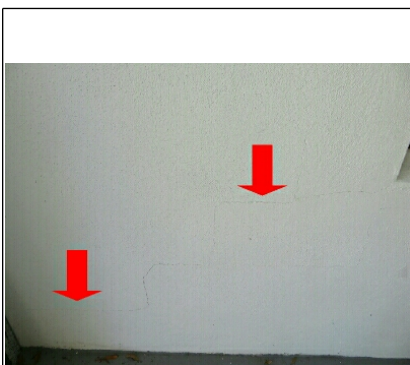
Typical wall settling / expansion cracking visible

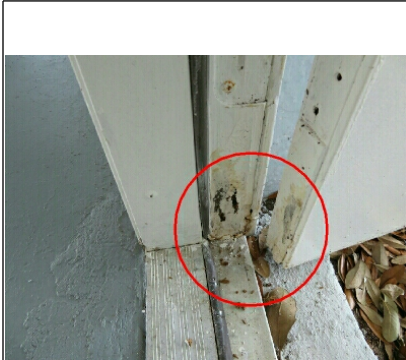
Garage Side Entry Door Weatherstripping: ☒ Satisfactory ☐ Marginal ☐ Poor ☐ Missing ☐ Replace
 Door condition: ☐ Satisfactory ☒ Marginal ☐ Poor ☐ Repair/Replacement
 Comments: Garage entry door framework / trim showing signs of deterioration.

Garage entry door framework / trim showing signs of deterioration

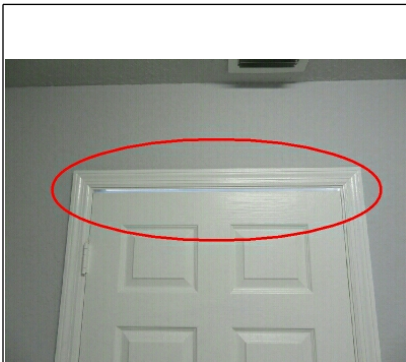
Entry door is short of framework / trim and has air gap on top of door, recommend repair

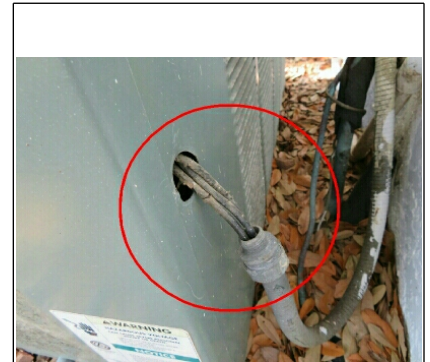
Electrical sealtight connection damage, exposed live wires present, recommend repair

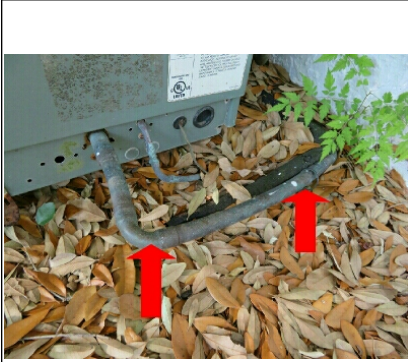
Pipe Insulation is missing,
recommend installing proper
installation to ensure maximum
efficiency

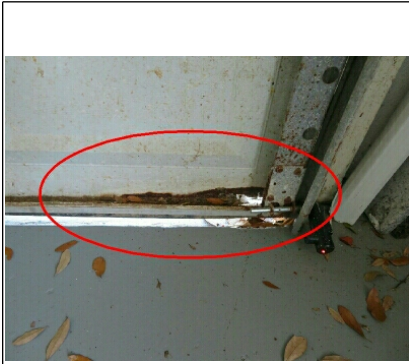
Garage door showing signs of deterioration / rusting

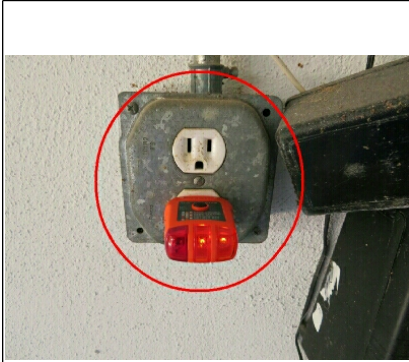
Comments No GFCI present in garage, recommend installing GFCI outlet / outlets to ensure maximum safety.

No GFCI outlet protection present

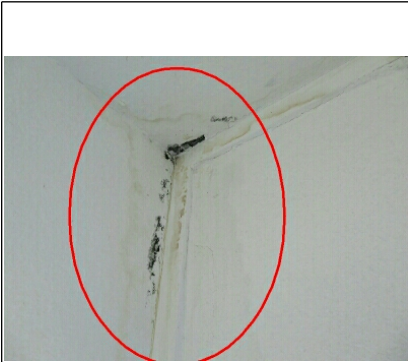
Water stain in garage ceiling / wall section.

Note : Garage ceiling and walls appeared to have been recently painted which would indicate that the roof perhaps is still leaking.

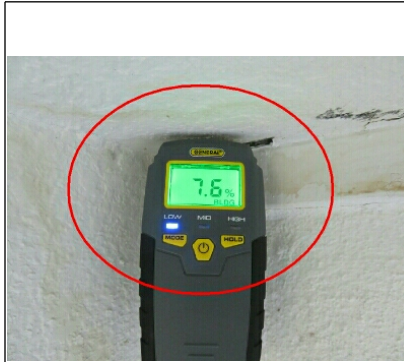
No elevated moisture reading when tested

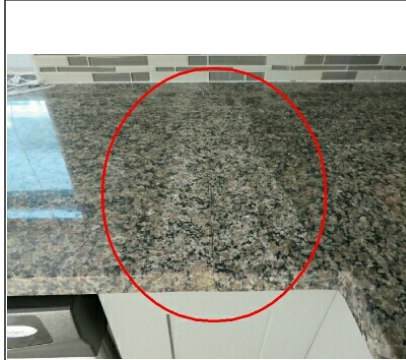
Countertop has damage / staining and joint seam, recommend repair/cleaning as needed.

Counter top seam is damaged / stained

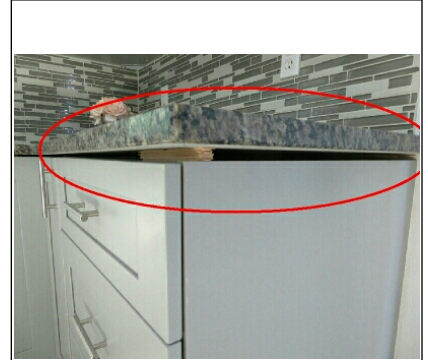
Base cabinet appears to have been installed out of level and counter top needed to be shimmed, to make seam joint proper

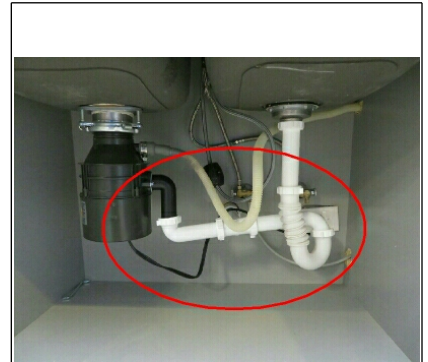
Sink plumbing drain line connections, recommend repair / realignment / adjustment of the drain piping to ensure proper drainage

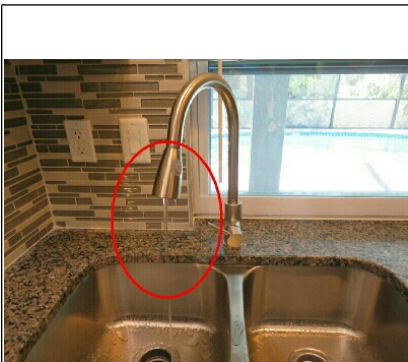
Hot water flow is poor, recommend repair as needed

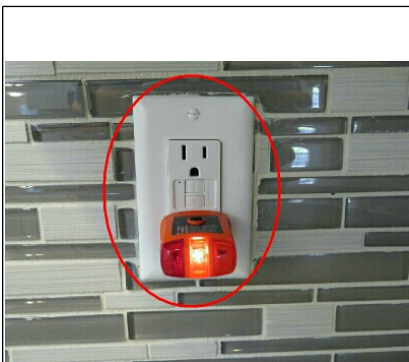
GFCI outlet improperly wired
open ground

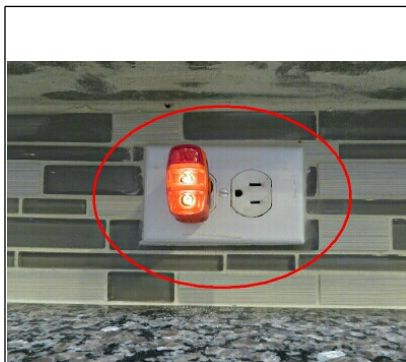
No GFCI outlet protection present

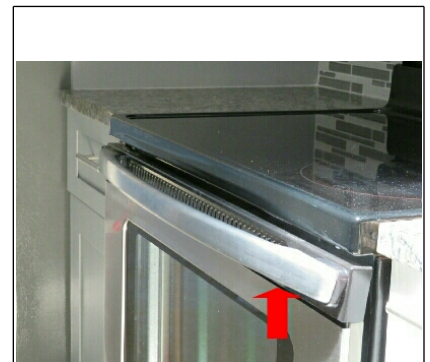
Stove handel is damaged

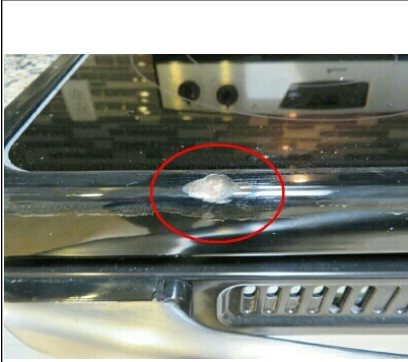
Stove top has chip

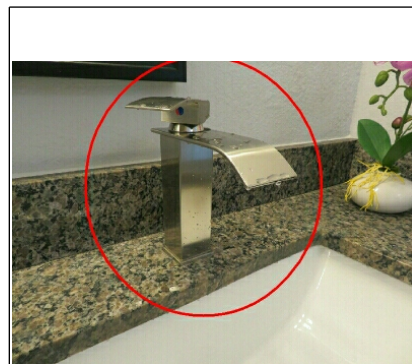
Right sink faucet is loose
recommend refastening

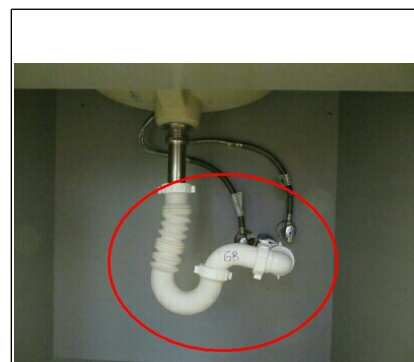
Sink plumbing connections, recommend repair / realignment /adjustment of the drain piping to ensure proper drainage

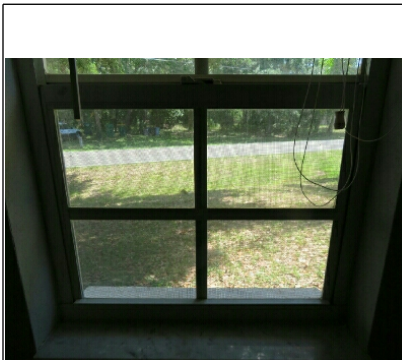
Southeast window has damaged operating balancer hardware

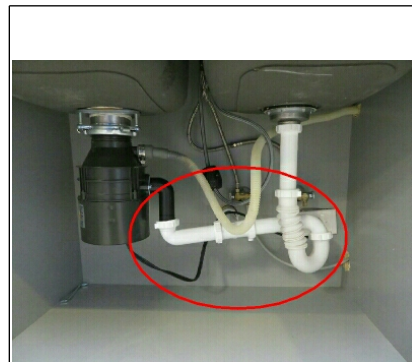
Typical Sink plumbing drain line connections, recommend repair / realignment / adjustment of the drain piping to ensure proper drainage

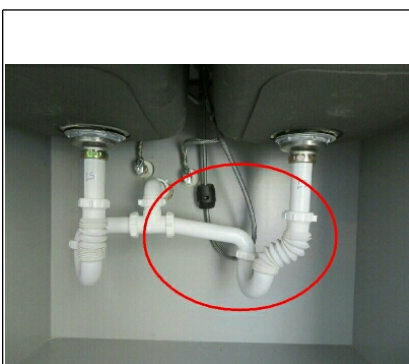
Typical Sink plumbing drain line connections, recommend repair / realignment / adjustment of the drain piping to ensure proper drainage

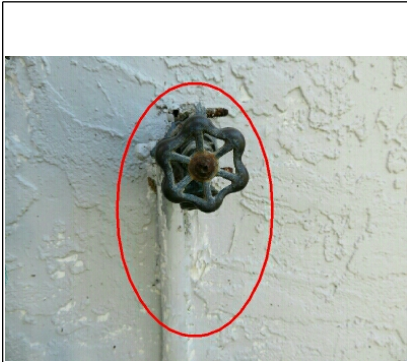
West hose bib was leaking,
recommend repair / replacement
as needed

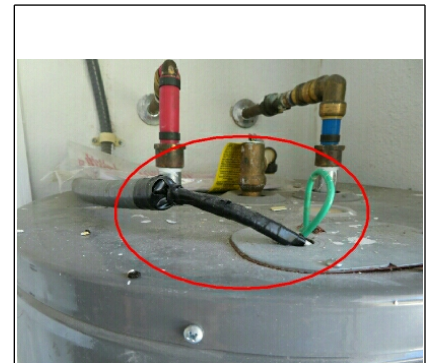
Note; Size / Efficiency and longevity of Hot Water Heater not evaluated within scope of this inspection.
There is improper wiring connection visible, unprotected exposed wires not within proper conduit or sealtight tubing.

Improper electrical wiring ,
exposed wires unprotected

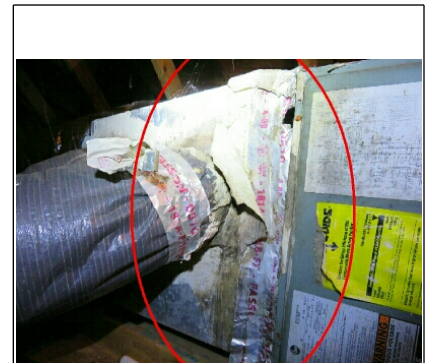
Recommend cleaning and resealing ductwork and plenum area

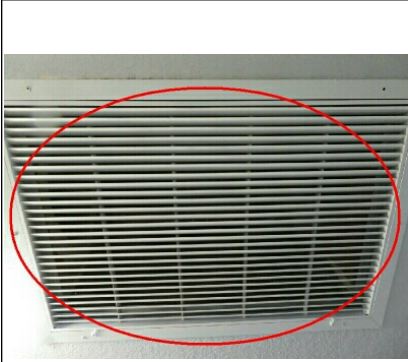
No return air installed

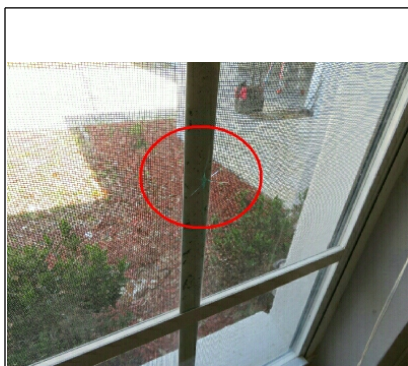
Cracked window glass
