Home Inspection Report

Port Charlotte, FL 33954

Wednesday April 17, 2019

041719-1

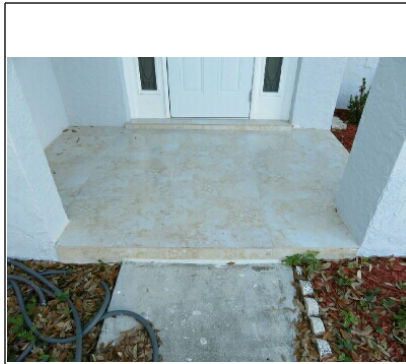
Note: Tile floor tile can be slippery when wet

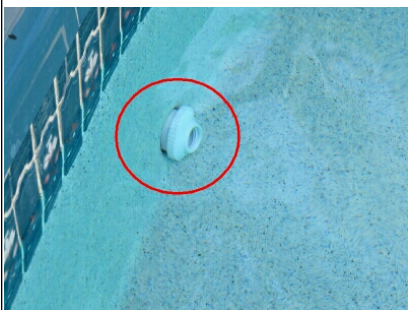
Possible water leak around discharge outlet

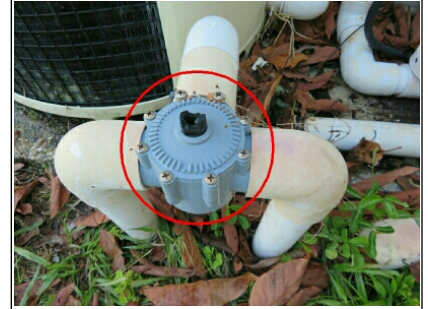
Control handel damaged / missing

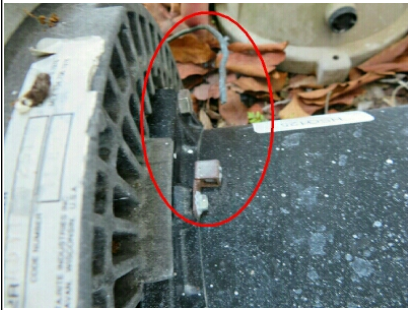
Pool motor Grounding wire not properly connected

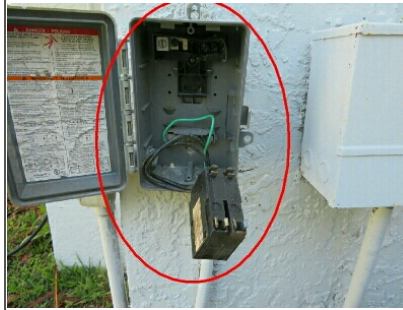
Pool heater panel has visible signs of damage / arcing recommend replacement

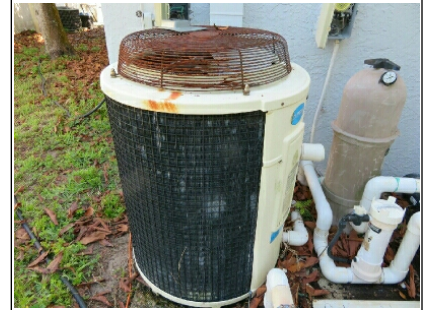
Note; There was a pool heater present, however was not connected electrically or plumbing.
 The electrical feed wires to pool heater have been removed from electrical panel to heater disconnect panel, rewiring is nessecary.
 There was evidence of minor water leak/stain detected at time of inspection in garage on ceiling / wall section above water heater.
 A/C Condenser / Compressor Unit not working at time of inspection, recommend service /repair by licensed HVAC contractor.
 Additional suggested / recommend repairs noted in report within specific related categories.

Pool heater Equipment not connected

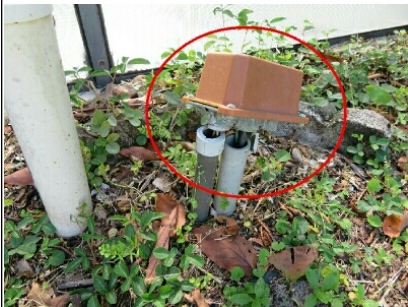
Pool light control box, has damage at conduit connections

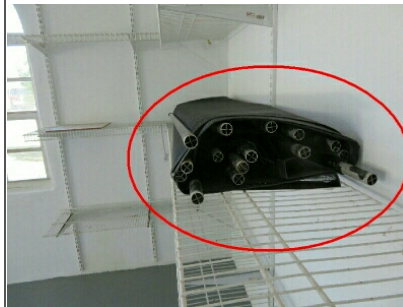
Child Safety Barrier fence stored in garage

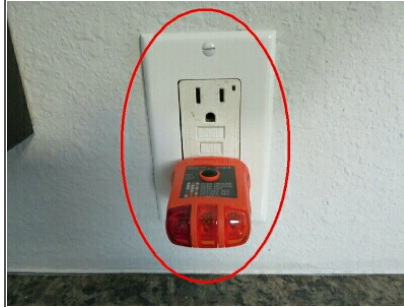
Masterbathroom GFCI outlet controls all lanai area outlet protection

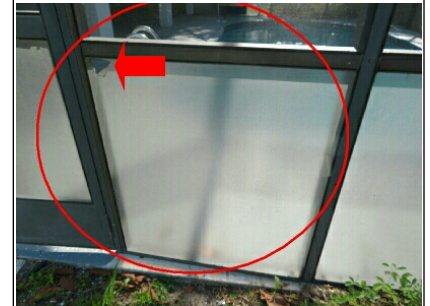
Screens/Frames Comments: Several screen sections have damage, recommend repair / replacement as needed.
 Pool cage replacement permit date 05/09/2006 ~ permit # 2006051751

Typical damaged / ripped screen section

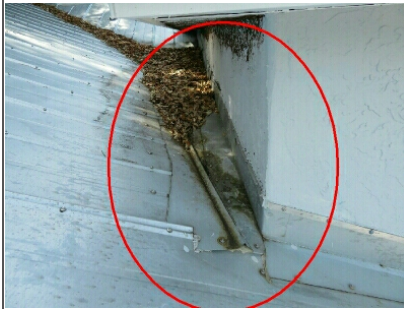
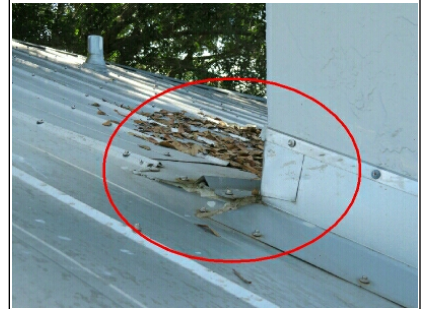
Comments Roof #1: Roof was showing normal wear and was in overall satisfactory/marginal condition, however it will need minor maintenance. (Only rated marginal due to minor roof leak)

Note: The soffit section appear to have been recently painted, in the area where garage ceiling was stained the soffit material has signs of water damage and rust, which would indicate that the roof perhaps is still leaking . However there was No elevated moisture reading detected when tested at time of inspection. Recommend further investigation by licensed roof contractor.

Possible area left of entryway where water leak is coming from.

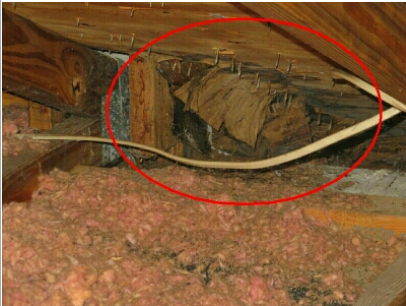
Damaged / deteriorated plywood roof decking in the area where roof has been leaking

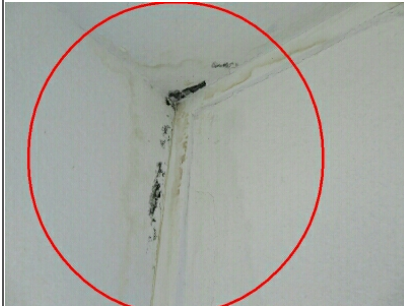
Water stain in garage ceiling / wall section.
Note : Garage ceiling and walls appeared to have been recently painted which would indicate that the roof perhaps is still leaking.

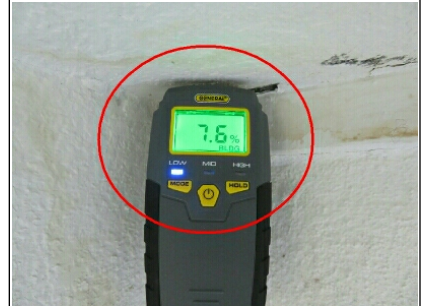
No elevated moisture reading when tested

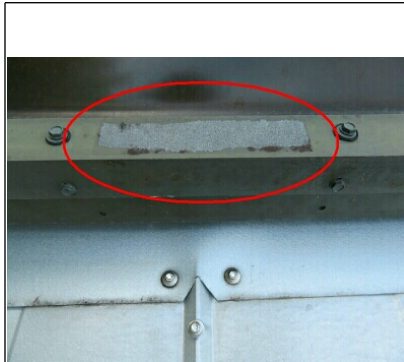
Skylight data tag not legible

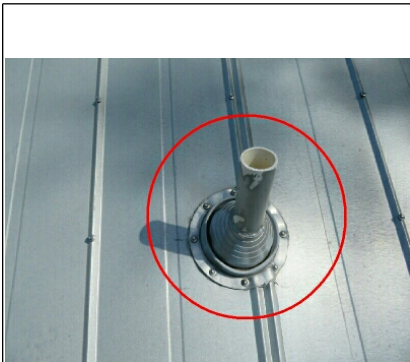
Typical plumbing vent pipe
Note: This type of pipe flashing
boot will need maintenance /
sealant to prevent future water
entry

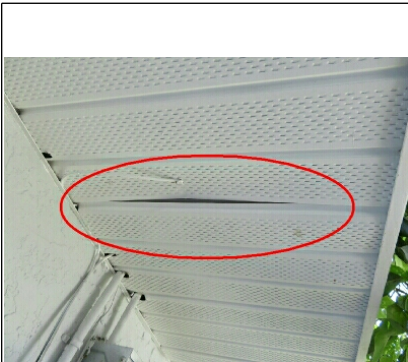
Dented soffit section

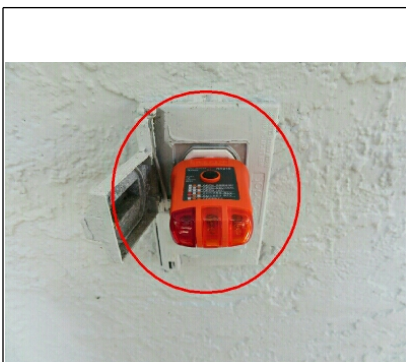
East electrical outlet had no power at time of inspection

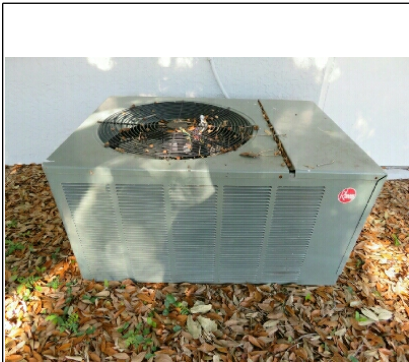
Comments Note; Size / Efficiency and longevity of HVAC System not evaluated within scope of this inspection.
 A/C Condenser / Compressor Unit not working at time of inspection, recommend service /repair by licensed HVAC contractor.

A/C Condenser / Compressor Unit " Rheem "

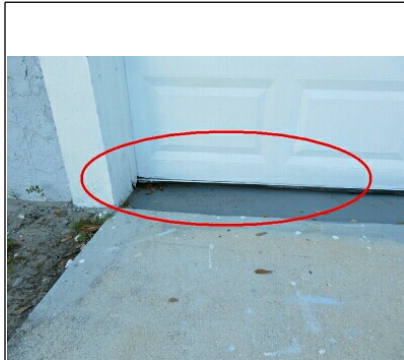
Overhead garage door not closing tight on left lower corner

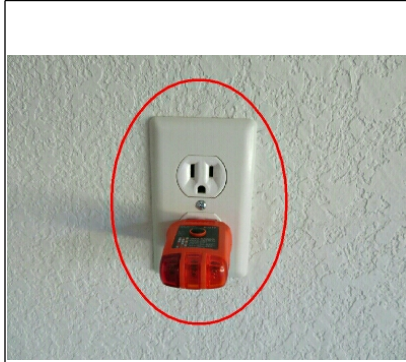
Electrical outlet on North wall did not have power at time of inspection

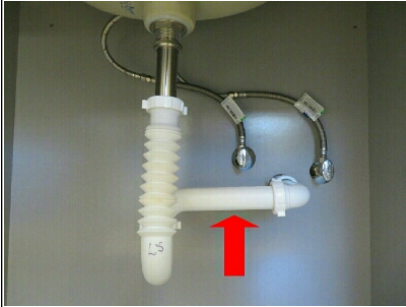
Left Sink plumbing connections, recommend repair / realignment /adjustment of the drain piping to ensure proper drainage

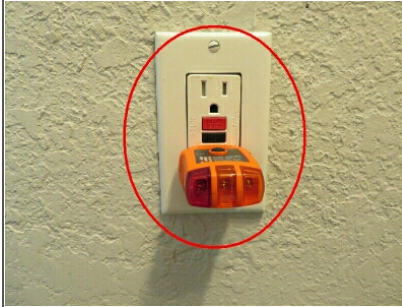
Comments Sink plumbing connections are improperly pitched, recommend repair / realignment /adjustment of the drain piping to ensure proper drainage
 Electrical outlet had no power at time of inspection, recommend repair / replacement as needed by licensed electrical contractor.

Electrical outlet had no power at time of inspection, recommend repair / replacement as needed by licensed electrical contractor

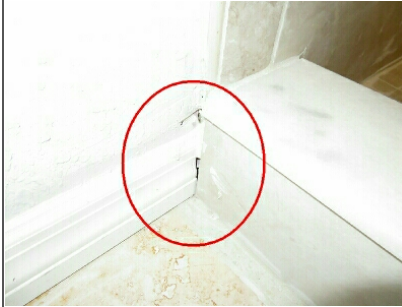
Shower area ☒ Ceramic Tile ☐ Fiberglass ☐ Cultured Marble Condition: ☐ Satisfactory ☒ Marginal ☐ Poor
☐ Rooted floors Caulk/Grouting needed: ☒ Yes ☐ No
 Where: Recommend adding caulk sealant / grout where wall tile meets threshold lower left corner at front face tile, also at window operating hardware.

Recommend adding sealant /
caulking to prevent future water
entry lower left corner at
threshold

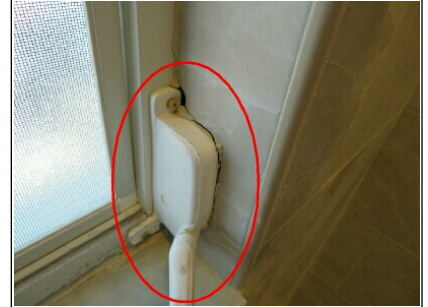
Recommend adding sealant /
caulking around window
operating hardware to prevent
future water entry

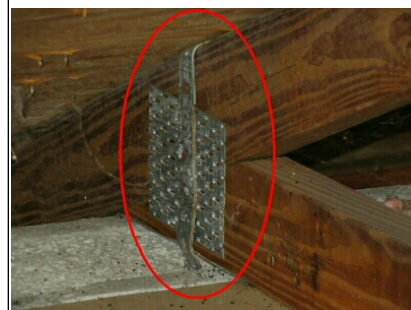
Truss to wall attachment strapping over top, however only two visible fasteners nails present

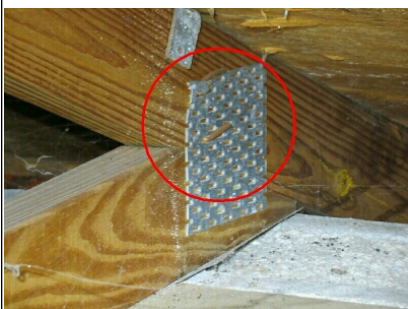
Only two visible fasteners nails present

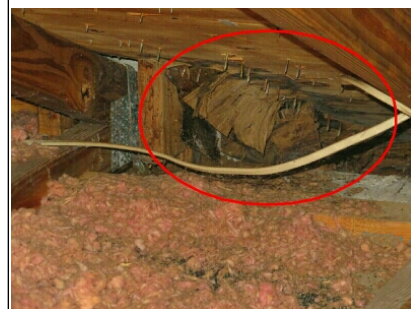
Damaged / deteriorated plywood roof decking in the area where roof has been leaking

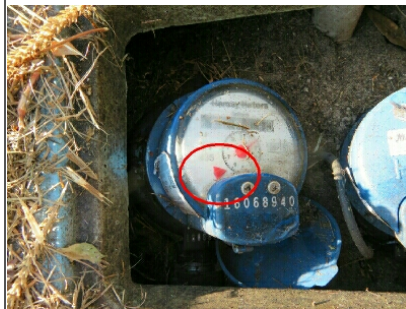
There was no visible signs of movement on water flow wheel located on water meter when observed

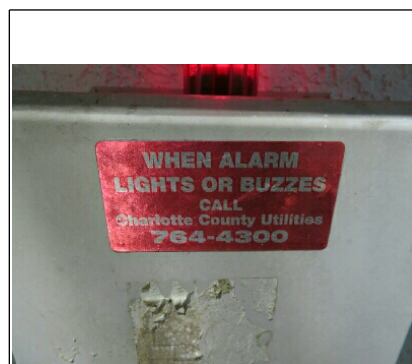
Septic system alarm was sounding off , contact Charlotte county utilities

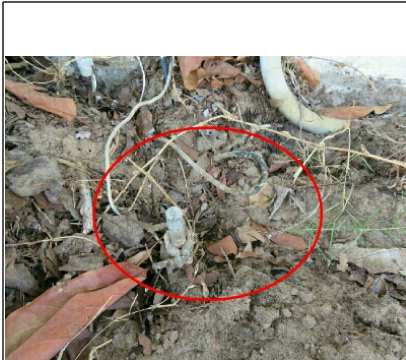
Comments No signs of overheating were evident at the time of the inspection.
Grounding Rod clamp connection is deteriorated, the clamp/wire are not properly attached to grounding rod.
Recommend repair by licensed electrical contractor.
GFCI breaker not operating, or even if this breaker is used for that purpose. Recommend further evaluation by licensed electrical contractor.

Electrical service grounding
clamp / wire are not properly
attached to grounding rod
